DECADE HOME INSPECTIONS

## RESIDENTIAL INSPECTION REPORT

24 Richard Ave  
Toronto, ON M4L 1W9

03/31/2026

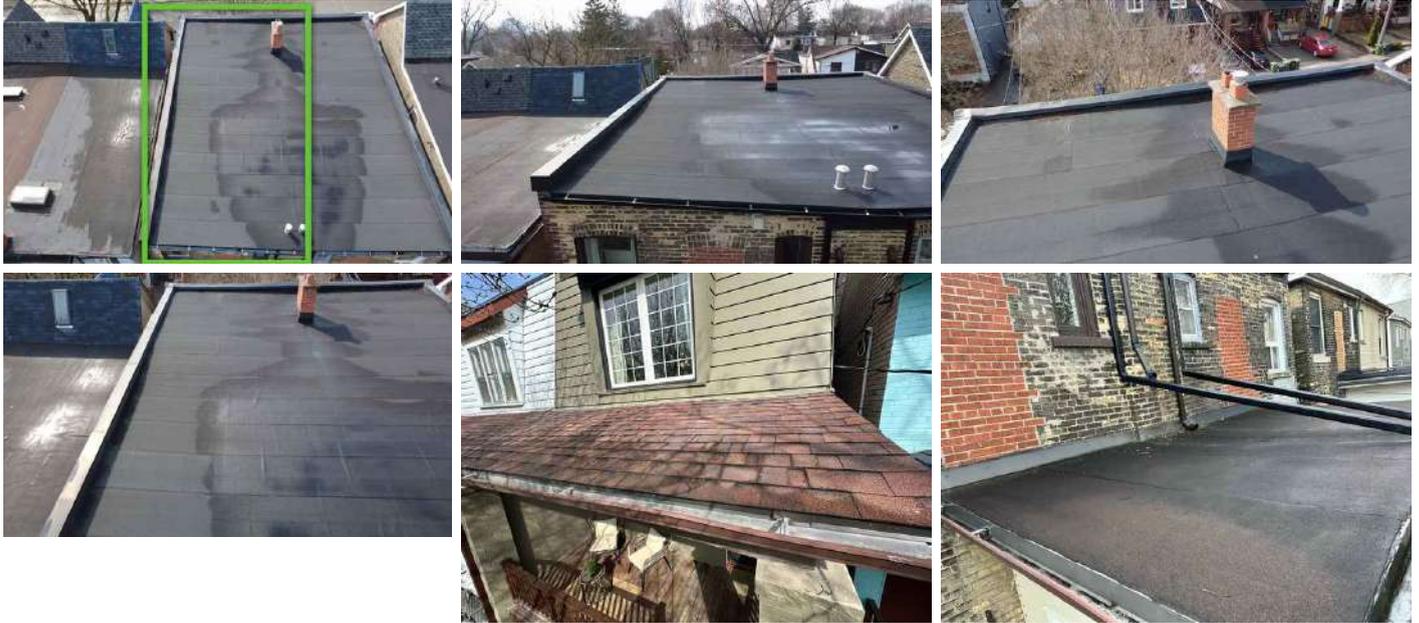
**Coverings: Material**

Modified Bitumen Roof, Asphalt Shingles

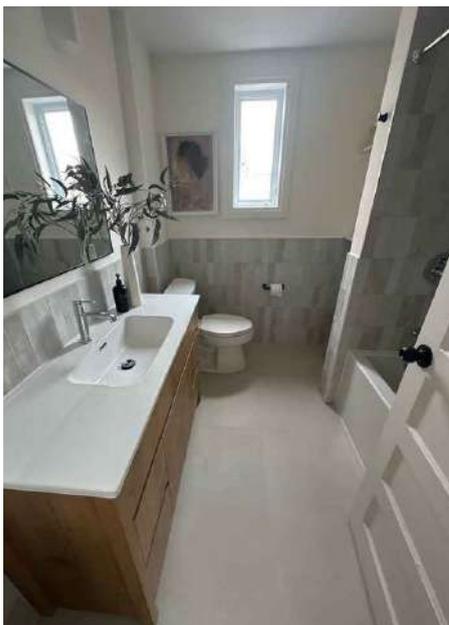
## Full Bathroom: Full Bathroom

The toilet, sink, and shower faucet were tested and functioning properly the day of the inspection.

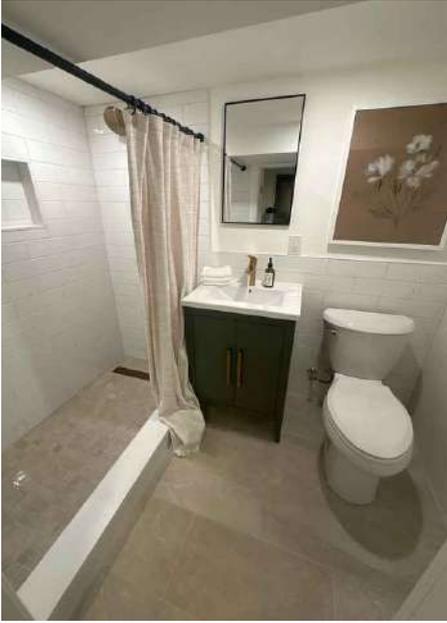
**Basement Full Bathroom: Basement Full Bathroom**

The toilet, sink, and shower faucet were tested and functioning properly the day of the inspection.

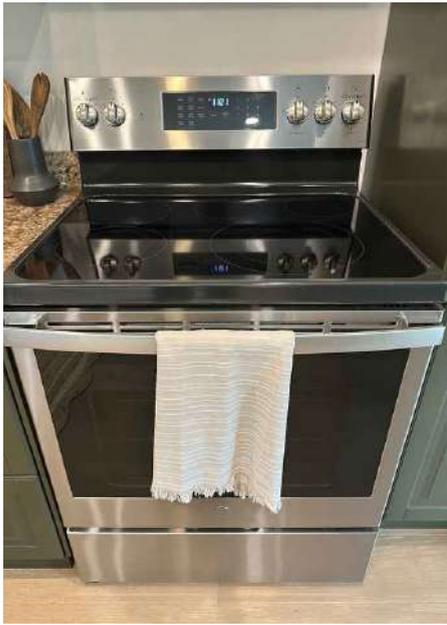
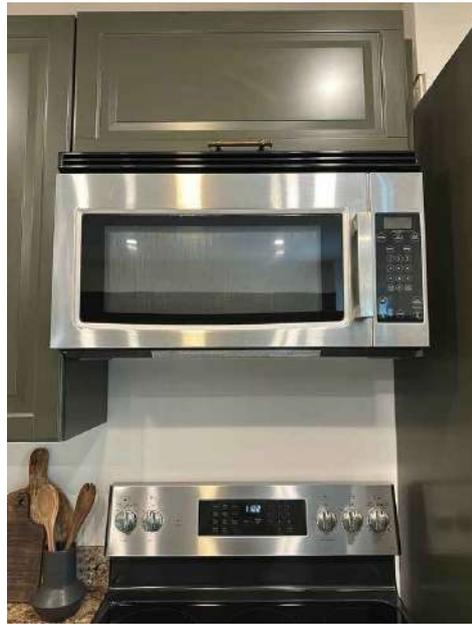
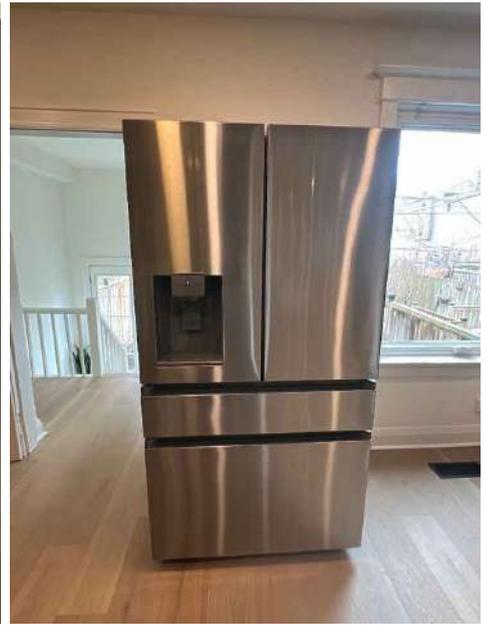
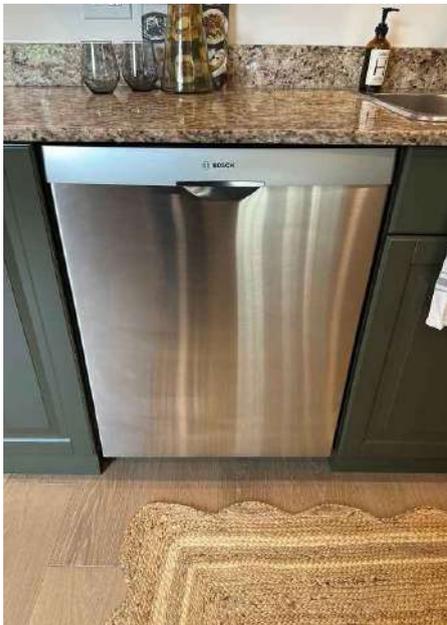
## Kitchen : Appliances

The kitchen appliances were briefly operated to confirm basic power and function. Full performance testing, cycle effectiveness, calibration, and life expectancy are beyond the scope of a home inspection.

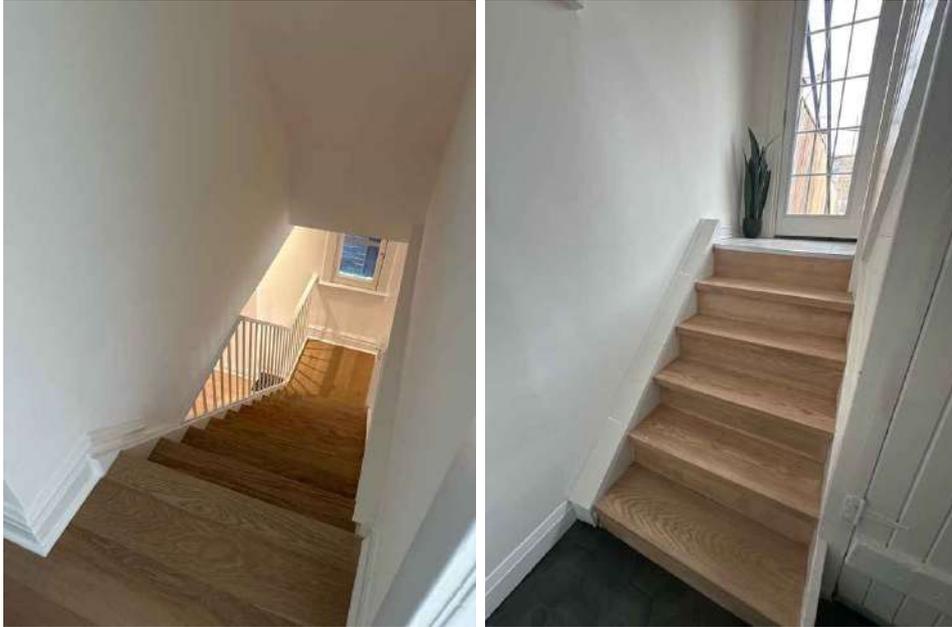
**MISSING HANDRAIL (FALL HAZARD)**

Missing Handrail

Recommend installation of a properly secured handrail to meet safety standards and reduce fall risk.

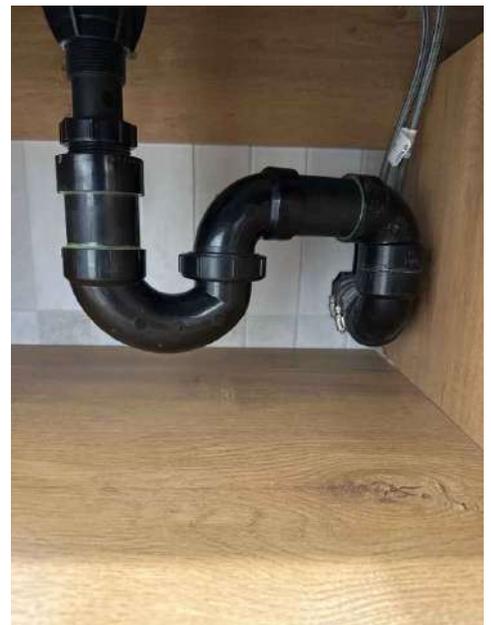
**S-TRAP OBSERVED AT PLUMBING FIXTURE (FUNCTIONAL/PLUMBING ISSUE)**

Observation: An S-trap was observed at a plumbing fixture. This type of trap can allow sewer gases to enter the home and is not considered current best practice.

Recommendation: Have a qualified plumber modify the drain configuration to a properly vented P-trap in accordance with current plumbing standards.

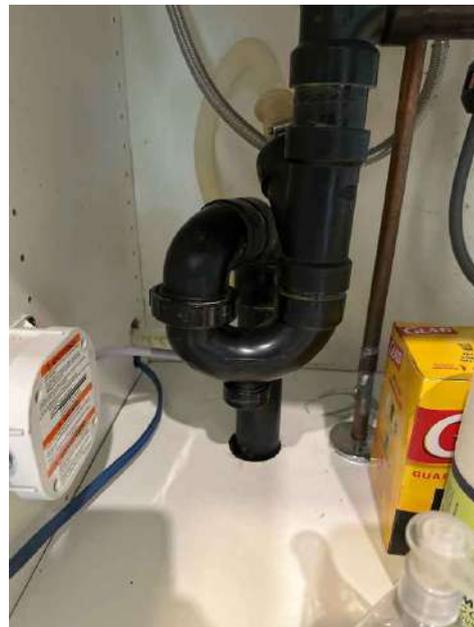
**S-TRAP (FUNCTIONAL/PLUMBING ISSUE)**

Observation: An S-trap style drain configuration was observed in the kitchen. S-traps are no longer permitted under modern plumbing standards because they can self-siphon, allowing the trap to lose its water seal. Loss of the trap seal may permit sewer gases to enter the living space.

Recommendation: Recommend correction by a licensed plumber. The drain should be reconfigured with a properly vented P-trap in accordance with current plumbing standards.

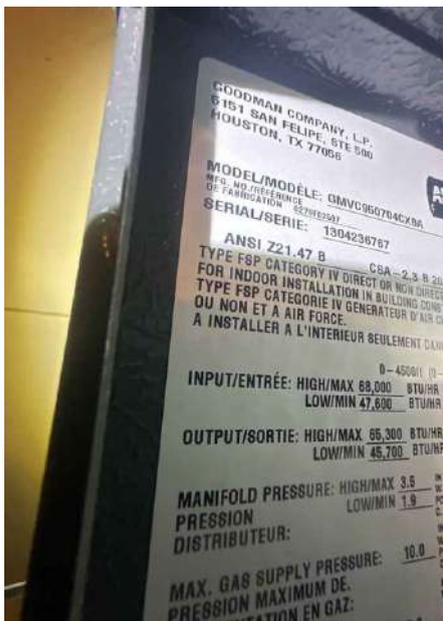
### Equipment: Energy Source

Natural Gas

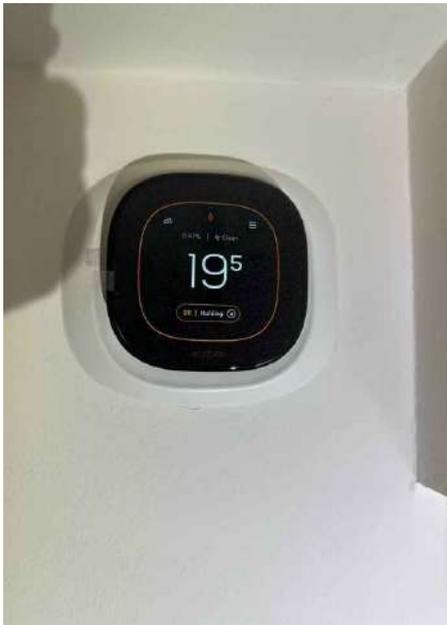
Programmable Thermostat

**Thermostat:** a device that automatically regulates temperature, or that activates a device when the temperature reaches a certain point.

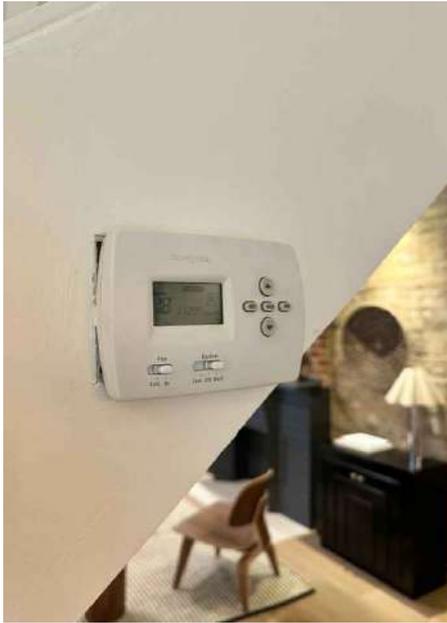
## Normal Operating Controls: Non-functioning Thermostat

A secondary older thermostat was observed but is no longer connected to or controlling the furnace. The system is now fully operated by the newer smart thermostat.

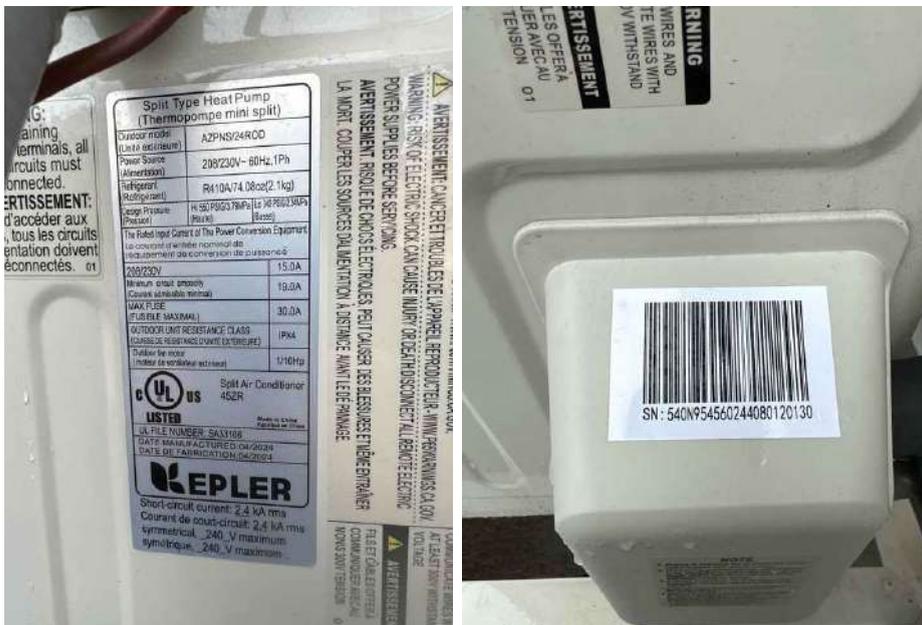
### Cooling Equipment: Model and Serial Number

Model: AZPNS/24ROD Serial: 540N954560244080120130

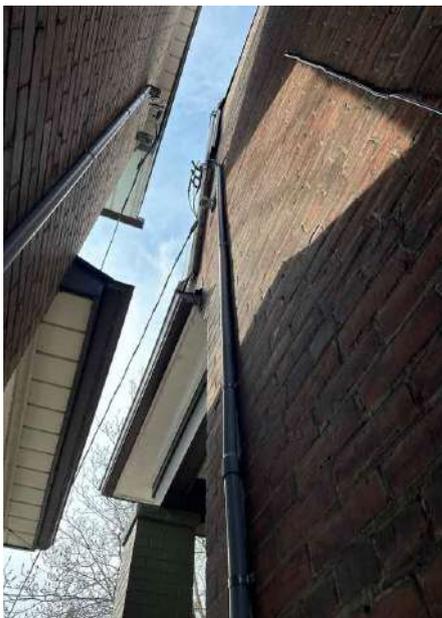
**Service Entrance Conductors:**  
**Electrical Service Conductors**  
 Overhead

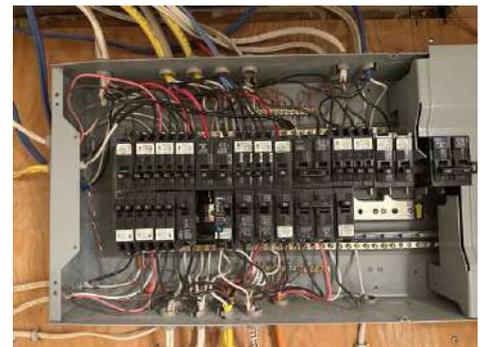
**Main & Subpanels, Service & Grounding, Main Overcurrent Device:** Panel Manufacturer  
 Siemens

**Main & Subpanels, Service & Grounding, Main Overcurrent Device:** Interior Panel  
 Observations

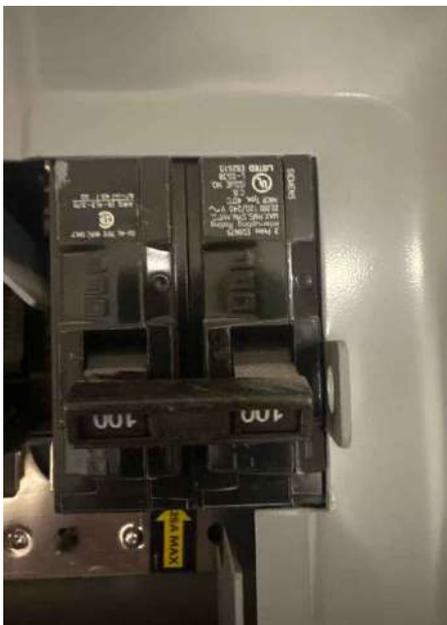
## Main & Subpanels, Service & Grounding, Main Overcurrent Device: Main Disconnect Location

On the Panel

The main circuit breaker is a large breaker usually located at the top of the panel but sometimes near the bottom or along one side.

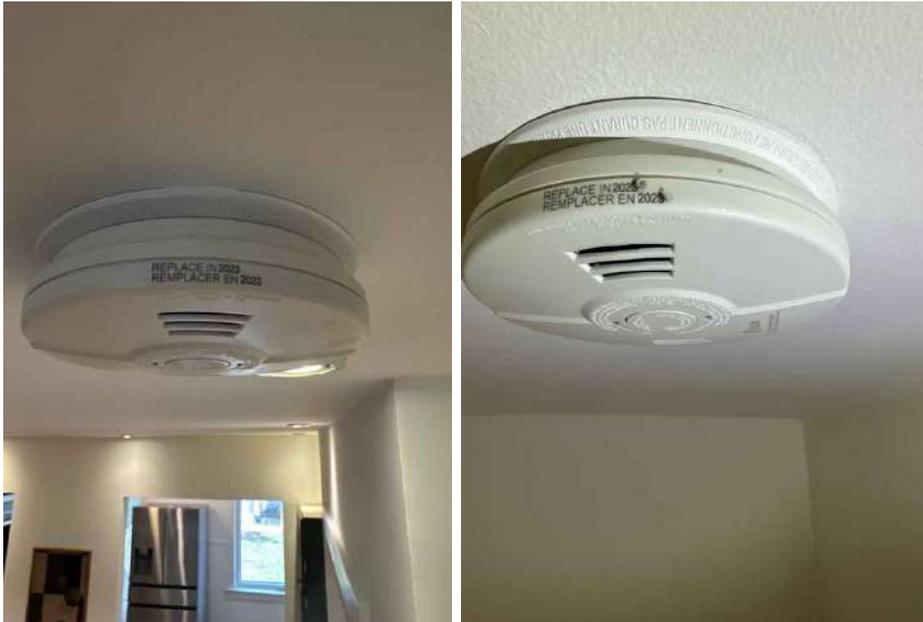
## Smoke & Carbon Monoxide Detectors: Condition

Operational (button tested), Expired

- Electrical panel: An incorrect breaker type was observed. This can affect proper circuit protection and should be corrected.
- Safety items: Smoke and/or carbon monoxide detectors appear to be older or expired and should be replaced.
- Interior safety: A missing handrail was noted at a staircase, which is a fall hazard.

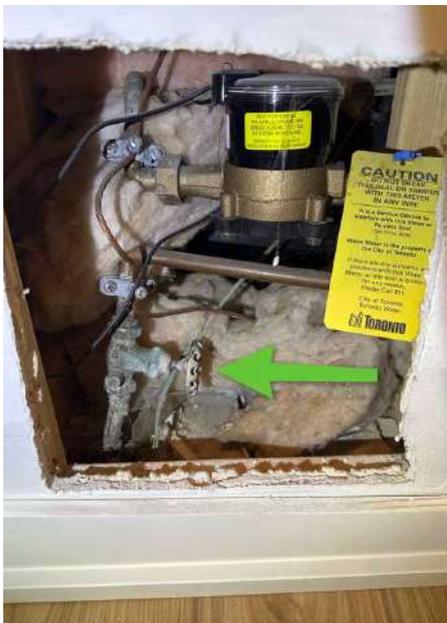
**Main Water Supply: Water Main Shut off and Meter Location**  
 Basement

**A main water shut-off valve** is a control valve located immediately downstream of the water meter, used to turn off/on all water flow to a property. It should be easily accessible and in good working order.

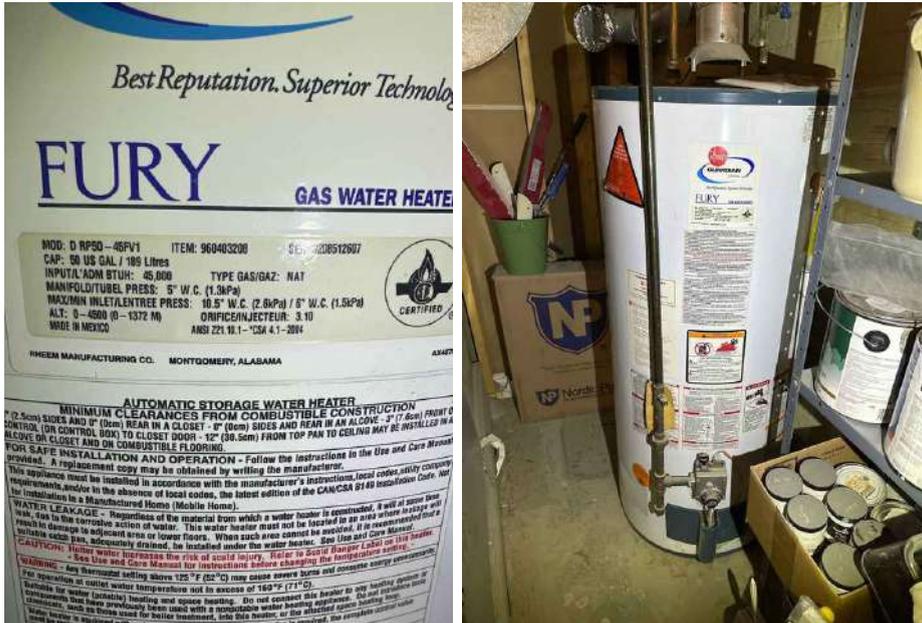
## Water Heating System: Brand / Model / Serial

- Brand: Rheem (Guardian Fury series)
- Model: D RP50-45FV1
- Serial: 0208512607
